## RAILWAY INVESTIGATION REPORT

R03W0169

### DERAILMENT

CANADIAN PACIFIC RAILWAY

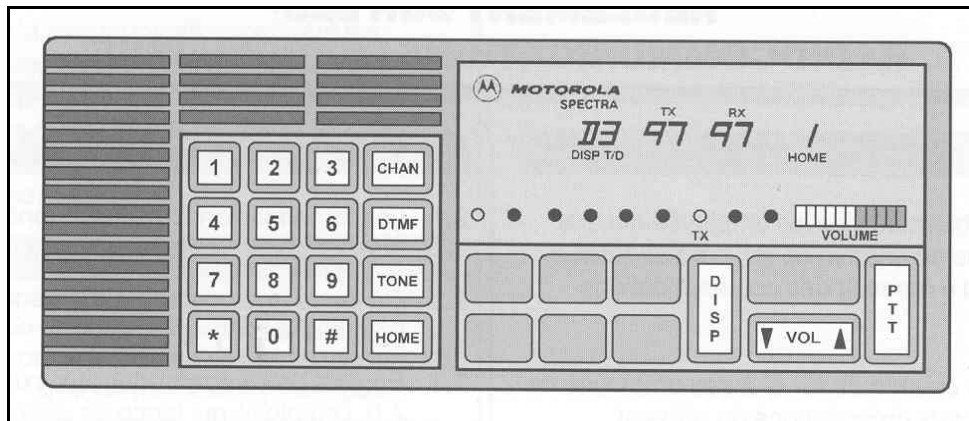
**Figure 1.** Motorola Spectra radio

The keypad on the Motorola Spectra radio is operated in the same fashion as a telephone push button keypad. During the course of the investigation, several CPR employees indicated that it is not uncommon to occasionally select the incorrect channel when operating this type of radio.

The location of the cab radio in the occurrence locomotive, a GE AC4400CW, likely contributed to the error of selecting the incorrect radio channel. The radio is located above the front window to the left of the locomotive engineer's seat, which is the present standard for GE locomotives. TSB tests demonstrated that, in GE locomotives with this type of cab layout, a seated individual of average height would have to stretch beyond their normal range of motion to reach the radio. This extra distance is approximately 6 inches with the left hand or 12 inches with the right hand. In comparison, radios in the GM SD-40-2 and SD-90 MAC locomotives, which are also used at CPR, are easily reached by an individual of average height seated in the locomotive engineer's chair. Although locomotive engineers are not restrained in their seats, having to reach beyond one's normal range of motion to access the radio buttons increases the probability of an error when entering the radio channel.

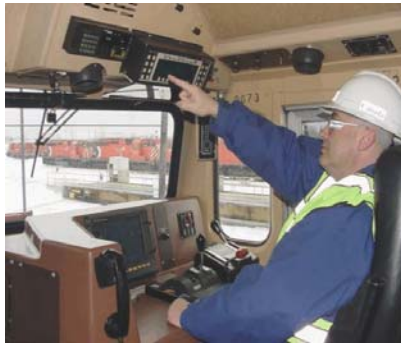
**Photo 1.** GE AC4400CW

Within the GE AC4400CW cab, a seated individual of average height would have to stretch approximately 6 inches with his left hand or 12 inches with his right hand to reach the locomotive radio. In comparison, because the radio in the GM SD-90 MAC is located to the right of the locomotive engineer's chair (above the window) and the radio in the GM SD-40-2 is incorporated into the standard control stand (to the left of the locomotive engineer's chair), these radios can be reached more easily than those in the GE cab. Photographs illustrating the location of each radio and the ease of reaching the radio with the right hand are shown below.
